**LOCAL FLOOD ANALYSIS
FOR THE
EAST BRANCH/MAIN STEM OF THE NEVERSINK**

**Prepared by:
Barton & Loguidice, D.P.C.
Syracuse, New York**

June 2016

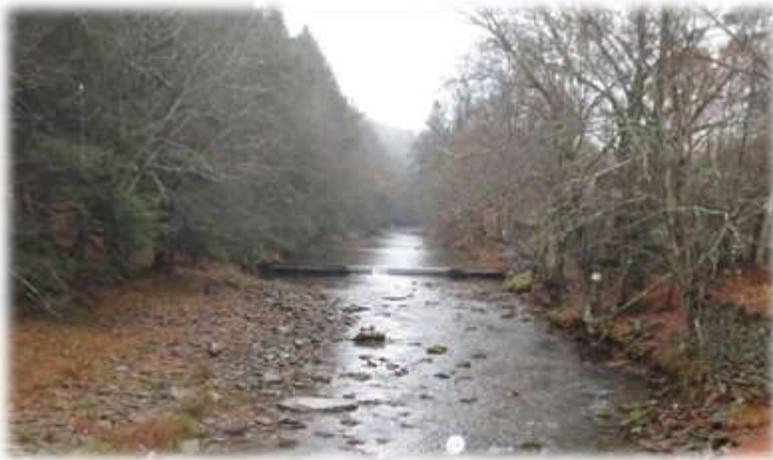
IV.B.1 Denning Road Dam near Red Hill Road

The small private dam that crosses the East Branch of the Neversink just upstream from the Denning Road Bridge near the intersection with Red Hill Road was identified as a potential contributor to flooding. The influence of the dam on flooding in the area was unknown. To fully compare the effects of the dam, an alternative was developed that removed the dam entirely. The alternative restored the grade of the channel. The reduction of flood elevations was approximately 0.5 ft for storms with a recurrence interval larger than 10-years. The influence of the removal was only observed approximately 700-800 feet upstream. This impacts the owner of the dam and 2 other houses upstream and across the road. Refer to Appendix A for the reduction in water surface elevations at each of the houses impacted.

While there is localized benefit from this alternative, it would not provide widespread benefits throughout the project area. The current owner of the dam was present for the presentation during which the model was discussed and though he did not return to see the results of the model at the later meeting, his desire to retain the dam in place was noted. Following Irene, he made an investment to repair the dam and expand on the stone walls intended to protect the driveway which has suffered repeated flood damage.

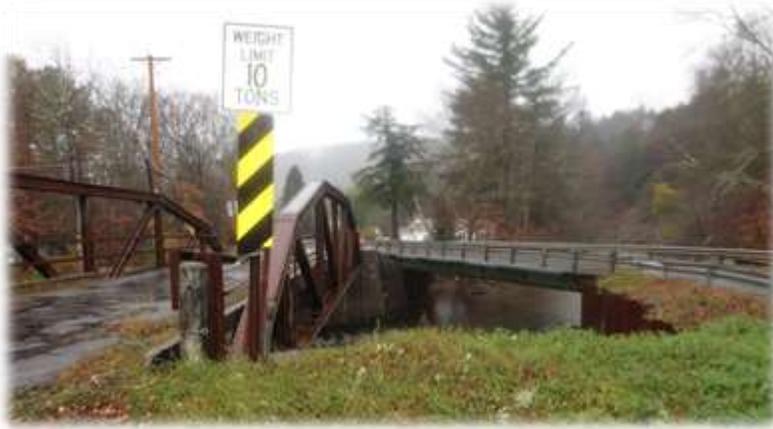
IV.B.2 “Double Bridge” at Town Hall

The influence of the existing truss bridge and the temporary bridge installed next to it was identified as a potential constriction along the East Branch of the Neversink. The presence of two bridges aligned at different orientations presented a location where a significant amount of energy was lost in the model resulting in backwater elevations upstream. The bridge was slated for replacement in 2015 and an initial concern was the size of the bridge being proposed by Ulster County. The replacement bridge being constructed by the County was modeled compared to the existing two bridge condition:

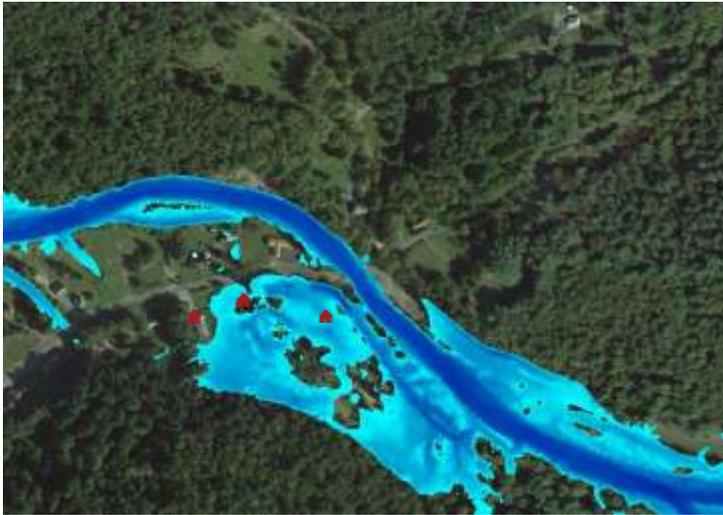
Figure 9 - Inundation Area during a 25 year event – Proposed Conditions

The proposed low beam elevation of the new bridge is 1699.84. The improved opening results in backwater elevations that are reduced by approximately 1 foot for the larger storms. The freeboard, or distance between the low beam and the water surface, for the 50-year storm is 0.4 feet. A storm between the 25- and 50-yr flows would inundate the approach roadway southwest of the bridge. It appears that the flow is getting over to Saw Mill Road at an upstream cross section which is inundating the southwest approach. The berm upstream of the bridge in the left floodplain is overtopped between the 25 and 50-year storms.

While the model showed that conditions are improved with the proposed bridge design, there is still flooding along the south approach. This flooding is what shuts down the road to vehicular traffic and results in water traveling down Denning Road towards the center of Claryville. To address this issue, an option to raise the road out of the floodplain was evaluated. This was combined with 1) a 60foot long bypass culvert to carry under Denning Road the water coming from Saw Mill Road when higher flows overtopped the berms, and 2) stream channel modifications downstream of the bridge, including a 100 foot wide floodplain bench along the south bank of the river where the Town Hall currently sits, and a smaller bench in front of the failed slope along the north bank to mitigate erosion. This last treatment would also reduce velocities at the toe of the failed slope, allowing the bank to be stabilized. In order to accommodate the floodplain bench downstream of Denning Road, the Town Hall would have to be relocated to facilitate this project. While a major project, this reduces flood elevations significantly and reduces the risk for several houses in this segment for floods with a recurrence interval greater than 50 years. Refer to Appendix A for the reduction in water surface elevations at each of the houses impacted.

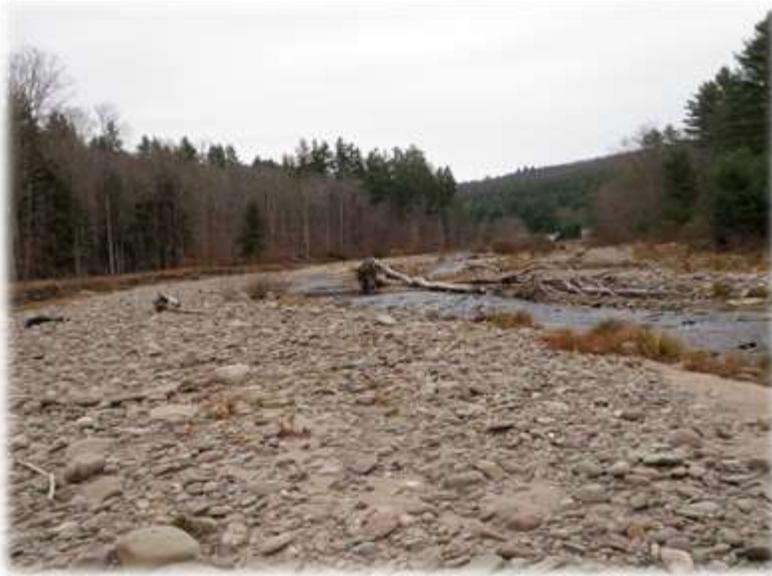
IV.B.3 DOT Stacked Stone Wall DS of County Line/"Wellington Site"

The area of concern is a 2600 foot length of stream beginning just upstream of the DOT stacked stone wall on Sullivan County Road 19 to a point just upstream of the Frost Valley Road Bridge. This reach of the stream was identified for several concerning features. The wall itself is being eroded along the toe, the stream is overly wide and braided, and appears to have experienced significant aggradation. In addition, this site was previously dredged following Tropical Storm Irene and the section along the stacked rock wall partially restored before being significantly reworked again by the September 2012 flood. The alternative evaluated at this site would reestablish the channel dimensions of the stream utilizing the data collected through the sediment transport model and the principles of natural channel design. By establishing the correct channel dimensions, there are three primary benefits. 1) The stream's ability to transport the gravel is brought into balance with what is delivered from upstream. This prevents the large scale aggradation of material that is currently observed at this location. 2) By establishing a channel form that is in balance, the stream becomes more stable. This

means that the large migrations of the stream from one bank to the other will be less likely to occur. There will be floodplain area between the DOT wall along Denning Road and the stream. This floodplain area will provide conveyance during larger storms reducing the impact to properties and stabilizing the toe in front of the DOT wall. 3) The development of a natural channel section and improved stream slope results in the reduction of water surface elevations in this reach. The benefits of this project help meet multiple objectives. By stabilizing the stream, not only can a decrease in water surface elevations be achieved, but the volatility of the stream in this stretch is reduced leading to a more sustainable solution than traditional dredging and bank stabilization approaches. Refer to Appendix A for the reduction in water surface elevations at each of the houses impacted.

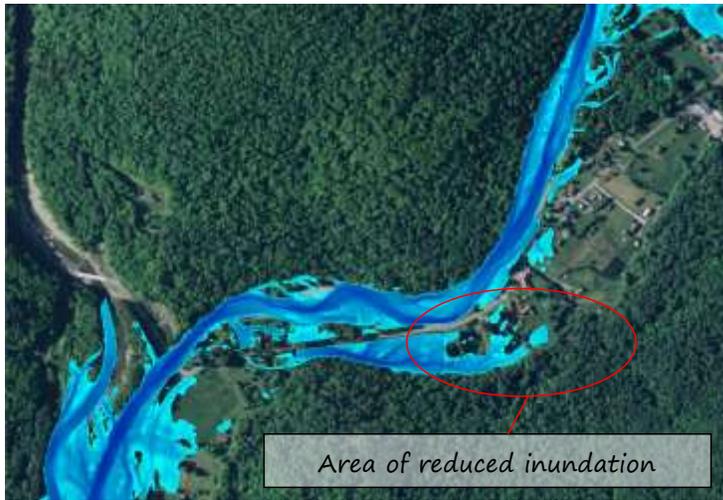
Figure 11 - Inundation Area during a 25 year event – Proposed Conditions

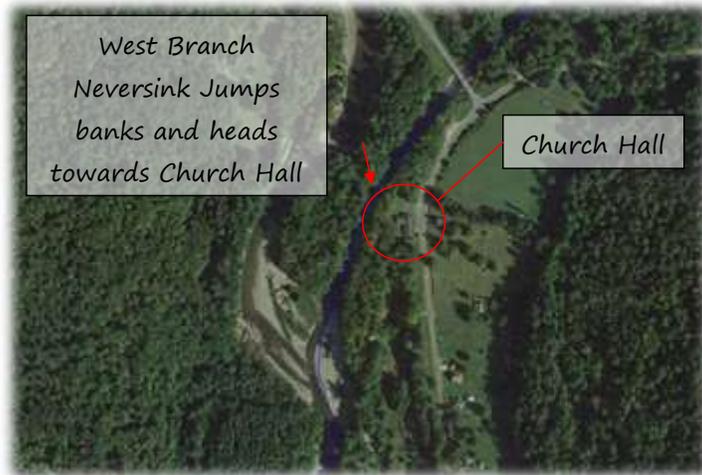
IV.B.4 Church Hall/Downstream of Frost Valley Bridge

The area of concern begins downstream of the Frost Valley Road Bridge and upstream of the confluence of the East and West Branches of the Neversink. Here, during large storm events, the West Branch of the Neversink River breaches the divide between the two branches, and partially spills into the East Branch channel before the true junction. The additional volume of flow in the East Branch channel potentially raises flood elevations at the church hall and in the floodplain downstream. An alternative was evaluated that looks at increasing the height of the “peninsula” between the two branches until the true junction about 750 feet downstream of the church hall. This would prevent flow from the West Branch of the Neversink from jumping into the East Branch until the true confluence. This alternative provides localized benefit to the church hall and adjacent buildings. Flood elevations are reduced by over 1 foot in the area immediately adjacent to the channel for all storms over the 10-year. Due to the localized nature of the benefits, another option at this location would be raising church hall above flood elevation.

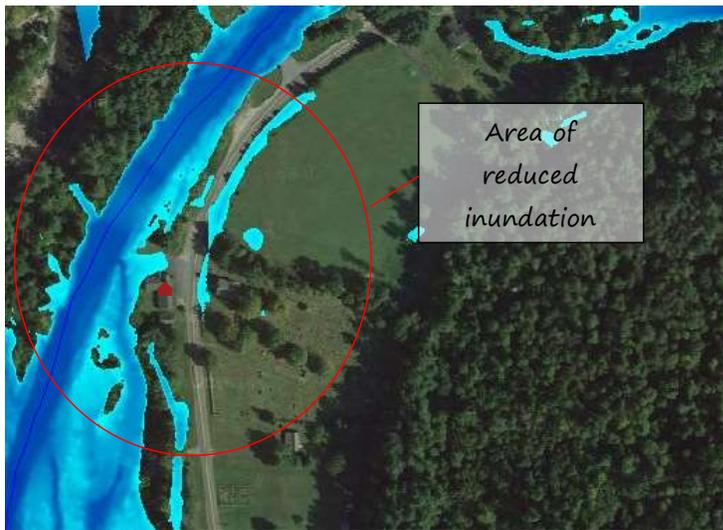
Figure 13 - Inundation Area during a 10 year event – Proposed Conditions

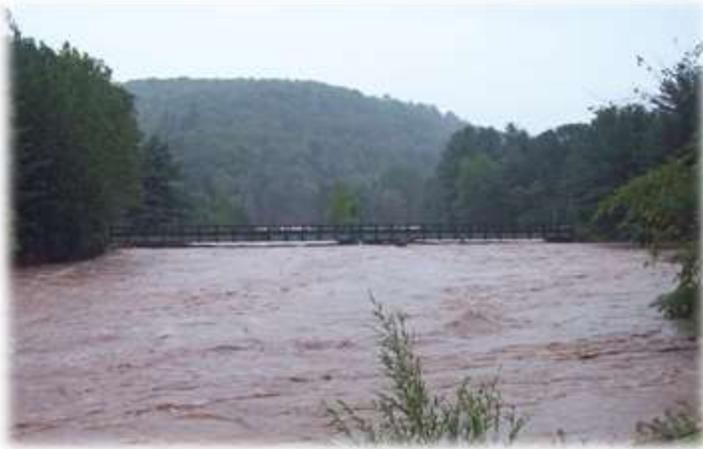
IV.B.6 Hunter Road and Hunter Road Bridge

Hunter Road crosses the main stem of the Neversink River on a 196 foot long 2 span bridge, and then parallels the river through the floodplain for a distance of 1900 feet before turning west and up the valley wall. At the low point in the road, a culvert carries floodplain back-channel flows from north to south under the road in to a wetland on the south side of the road. Flood at this location resulted in a fatality in 2010 when a motorist entered the flooded roadway and was swept downstream. Our model indicates that Hunter Road is overtopped in events below the 10-year storm. Due to the volume water flowing across the floodplain, simply increasing the size of the existing culvert crossing near the spur to the covered bridge would not prevent the roadway from overtopping. To prevent roadway inundation, the roadway must be raised in excess of 3 feet in some low areas. A detailed survey of the roadway would be required to verify the quantities and locations of fill. Increasing the roadway elevation, adding a series of four 6 foot culverts and increasing the size of the existing culverts from 30 feet to 40 feet and 3feet to 10 feet could raise the road above the 100-yr flood elevation, while avoiding an increase in flood elevations upstream or downstream while. Refer to Appendix A for the reduction in water surface elevations at each of the properties impacted. The estimated project cost would be approximately \$2.5M. To clarify potential regulatory limitations,

impacts on protected wetlands down-valley of Hunter Road would also have to be evaluated.

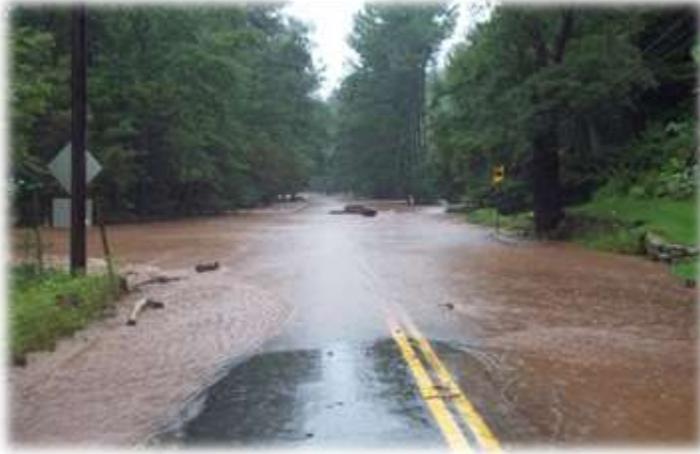
IV.B.7 Claryville Road near Hunter Road Bridge

Claryville Road just north of its intersection with Hunter Road floods during storm events. During our public outreach, the option of raising Hunter Road at this location a sufficient amount to raise it above the floodplain was suggested. In order to raise Hunter Road above the 100-year event, it would require raising the road by as much as three feet at the lowest area. Since Claryville Road is at the edge of the floodplain, raising the road had no impact on flood elevations. The limiting consideration with this alternative is the scale of the project. To accomplish the elevation goal, Claryville Road would be reconstructed for 2/3 of a mile and raised in elevation by as much as 3 feet. This would lead to Right-of-Way concerns, driveway impacts, and impacts to local drainage such as roadside ditches.

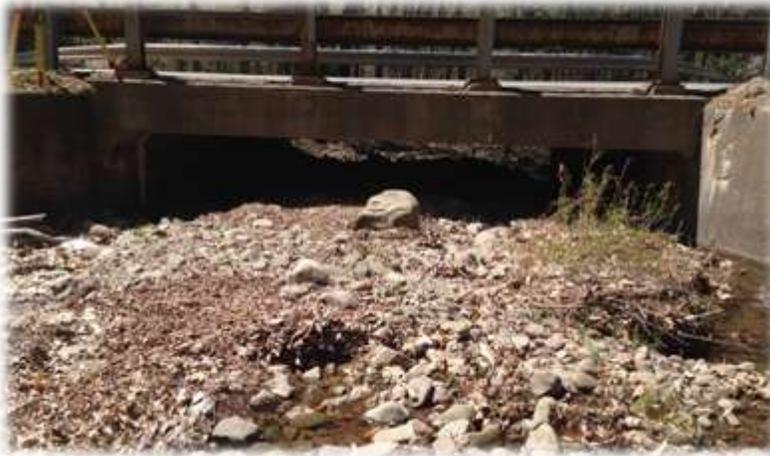
IV.B.9 Bungalow Brook at Claryville Road

Flooding has been observed by the community at the location where Bungalow Brook crosses through a culvert under Claryville Road. The flooding in the Bungalow Brook area appears to be caused by flow from Bungalow Brook backing up at Claryville Road. A TR 55 analysis of flood discharges at Bungalow Brook was completed to determine peak flows:

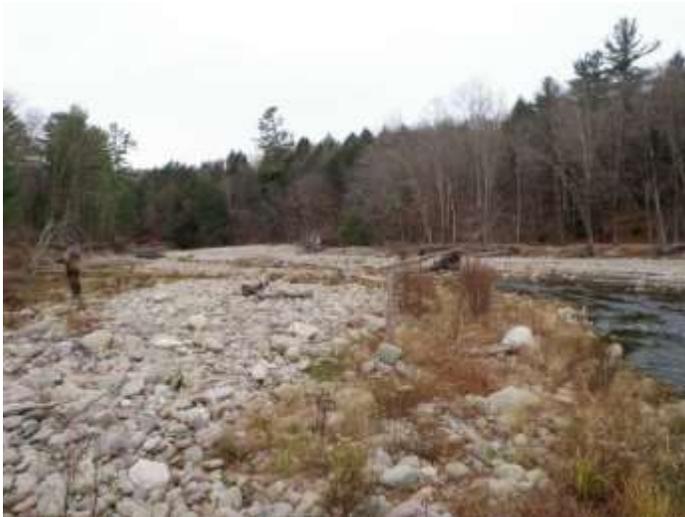
Figure 17 – Example Aggrading Section at Station 20+00

The sediment transport analysis completed for the project area supported the local consensus that the river is aggrading. During the field reconnaissance, data was collected at 21 sites throughout the East Branch and Main Stem of the Neversink River. Of these 21 sections, 14 (or two thirds) of the sections were aggrading or experiencing deposition. Aggradation is typically the result of over-widened channel conditions or excess sediment supply coming from eroding streambanks upstream. The key to minimizing the deposition is to restore a stable river section to a state that is capable of conveying the appropriate amount of material downstream. In order to accomplish this throughout the corridor, efforts will be made to minimize erosion at streambanks, hillslopes and other sediment sources as well as reshaping the channel form utilizing natural channel design to establish stable sections. The concept of aggradation/degradation was not looked at as a particular alternative to pursue, but rather ~~a concept~~ to better understand factors of aggrading and degrading conditions in the stream. This can aid intended for incorporation into all when designings and projects throughout the watershed in order intended to stabilize the streams and provide improved flood conveyance. The data collected as part of this study in combination with the hydraulic model are key tools to providing the foundation needed to support designs for these types of projects.

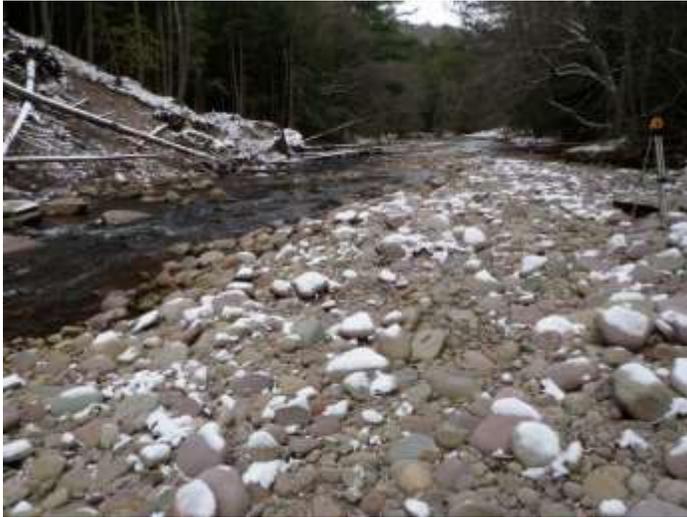
Figure 18 – Example Aggrading Section at Station 127+00
